Fluid Applied Roof System Solves Costly Abatement of ACM (Asbestos Containing Material) Roof Deck.

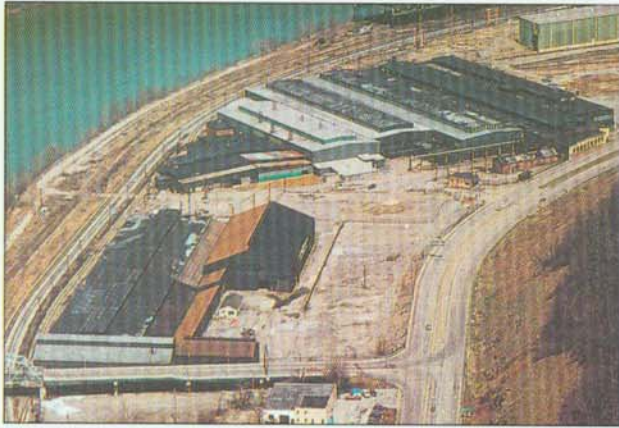
BEFORE

The comprehensive scope of the work made budgeting of an effective, economical roof critical. Large sections of the original roof were comprised of metal panels coated with asphalt containing asbestos. The cost to remove and dispose of these panels made replacement of the deck cost prohibitive and complicated the ability to retrofit new metal over the existing deck. With this in mind, the focus shifted to the possible restoration of this portion of the roof assembly. To satisfy cost, performance and safety concerns, the project architect, Design 3 Architecture of Monroeville, PA selected a rubber roof coating system previously used to restore the Galbestos roof deck at Cinergy Field (formerly Riverfront Stadium) in Cincinnati, Ohio. William Snyder of Design 3 Architecture remarked that "after looking at several options regarding the existing asbestos metal roofing, it was determined that since the roof was structurally sound, and due to our very tight budget, we could not and would not remove asbestos metal roofing. Truco afforded us the ability to meet our budget while providing a watertight containment that is aesthetically pleasing."

Surface preparation was the initial and possibly the most important phase of the project. Although the roof panels were structurally sound, some pinholing existed. D. L. Smith bridged these areas with a towel grade version of the rubber coating reinforced with a woven fabric. All fasteners were then tightened and generously coated with a viscous seam sealer to prevent leaks and secure the fasteners from backing out in the future. Vertical & horizontal seams were also addressed with the elastomeric sealant using an airless sprayer at low pressure. This approach yields a thick, two inch bead to bridge vulnerable joints and seams throughout the roof.

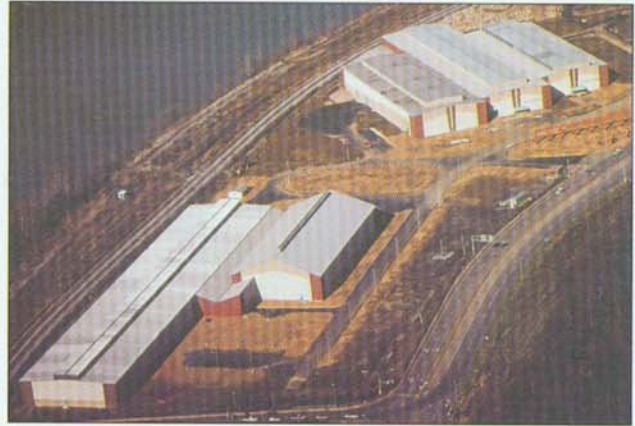
AFTER

Manufactured by Truco Inc, of Cleveland, Ohio, the Eterna-Seal fluid applied roof system provides a seamless, fully adhered rubber roof. The thermoplastic rubber coating is designed to waterproof, protect and beautify a variety of substrates including metal, Hypalon, transite, and smooth BUR surfaces. Over asphalt containing asbestos, the coating's exceptional bond

Once watertight, a specially formulated field coating was sprayed over the entire roof subject to FM-approved test data governing hail, UV and fire resistance. The coating's naphtha base penetrates into the asphalt substrate, thus assuring a bond that will not be subject to future delamination. Once cured, a second and final finish coat was applied to smooth out rough surfaces while adding additional protection. The finished application consists of 28 mils of rubber protection throughout the field, while seams, fasteners, and other details receive extra coverage totaling 45 to 50 dry mils. The durable and attractive roof restoration process adds little weight to the existing structure, while completely sealing out the elements. The manufacturer provides a 10 year, non pro-rated labor and material warranty which can be renewed in 5 year increments with a nominal amount of additional attention.
